**Flood Control Project Maintenance
Levee Inspections**

Fall 2014 Levee Maintenance Deficiency Summary Report

Reclamation District No. 0554 Walnut Grove

Levee Inspection Report By Mile - Fall 2014

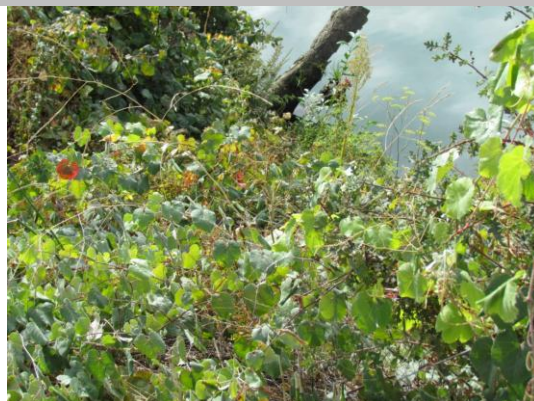
Photo 1 of 1 : FA_2014_RD0554_176_11_20141125_00012.jpg

LM Start	0.09	Rating **	U	Issue No.	11
LM End	0.09	Issue Type +	Ma	Location *	WS
Category	Earthen Levee			GPS Latitude/Longitude	
				Start	End
Item	Erosion / Bank Caving			38.248262 °	38.248262 °
				-121.509901 °	-121.509901 °
DWR ID	DWR_RD0554_01_s_2014_11				
Action/Comments					
Note and monitor erosion site. Inspector Comments: This is not a new erosion site, repairs are needed. One tree has fallen into the Sac River at the erosion site. There are many more trees at that same location.

Erosion on waterside toe dead tree fallen at erosion site.

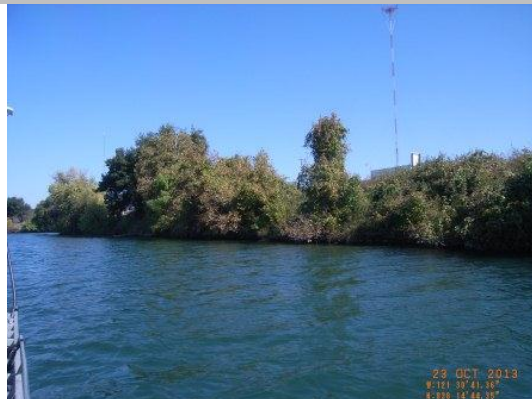
Photo 1 of 2 : FA_2014_RD0554_176_2_20141008_00001.jpg

LM Start	0.25	Rating **	M	Issue No.	2
LM End	0.34	Issue Type +	Ma	Location *	WS
Category	Supplemental			GPS Latitude/Longitude	
				Start	End
Item	USACE Erosion Survey			38.246222 °	38.245017 °
				-121.510878 °	-121.511740 °
DWR ID	DWR_RD0554_01_f_2014_2				
Action/Comments					
Inspector Comments: 2009 - Tension cracks on road on top of levee. Erosion into the levee slope and mass failure. 2013: Short vertical sections at bank toe. [2013 Site ID: SAC_27-0_L]

USACE 2013 Photo #1

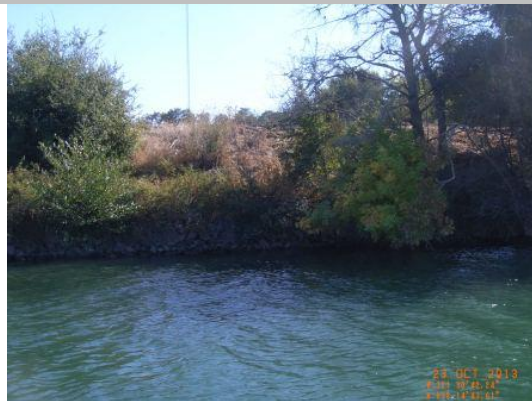
Photo 2 of 2 : FA_2014_RD0554_176_2_20141008_00002.jpg

USACE 2013 Photo #2

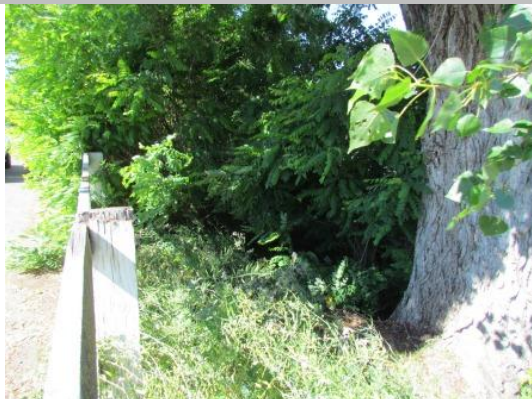
Photo 1 of 1 : FA_2014_RD0554_176_18_20141008_00010.jpg

LM Start	0.63	Rating **	U	Issue No.	18
LM End	0.75	Issue Type +	Ma	Location *	WS
Category	Earthen Levee			GPS Latitude/Longitude	
				Start	End
Item	Trim / Thin Trees			38.241547 °	38.240129 °
				-121.514617 °	-121.515973 °
DWR ID	DWR_RD0554_01_s_2014_18				
Action/Comments					
Thin trees to allow visibility of the ground and room to flood fight. Inspector Comments: No new photo taken Fall 2014. No change at this location.

Wooded tree growth along waterward shoulder and slope. Photo taken 06-05-2014. No new photo taken Fall 2014.

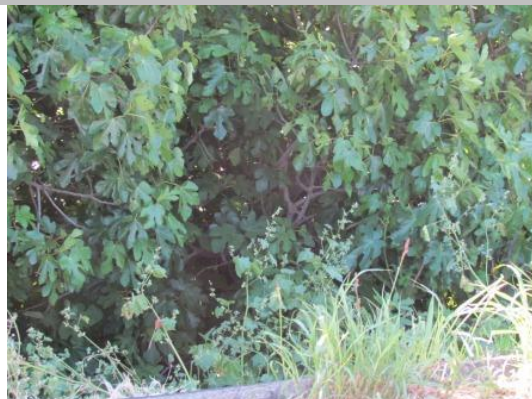
Photo 1 of 1 : FA_2014_RD0554_176_20_20141008_00011.jpg

LM Start	0.75	Rating **	U	Issue No.	20
LM End	0.79	Issue Type +	Ma	Location *	LS
Category	Earthen Levee			GPS Latitude/Longitude	
				Start	End
Item	Trim / Thin Trees			38.240128 °	38.239630 °
				-121.515974 °	-121.516418 °
DWR ID	DWR_RD0554_01_s_2014_20				
Action/Comments					
Thin trees to allow visibility of the ground and room to flood fight.					
Inspector Comments: No new photo for this issue Fall inspection 2014.

Wooded tree growth on landward levee slope and shoulders. Photo taken 06-05-2014. No new photo, no change to location during Fall inspection.

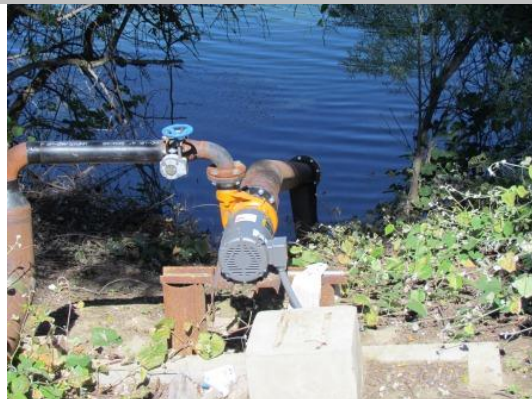
Photo 3 of 3 : FA_2014_RD0554_176_16_20141008_00009.jpg

LM Start	1.09	Rating **	U	Issue No.	16 (cont)	
LM End	1.09	Issue Type +	En	Location *	N/A	
Category	Earthen Levee			GPS Latitude/Longitude		
				Start		End
Item	Encroachments			38.235422 °		38.235422 °
				-121.517233 °		-121.517233 °
DWR ID	DWR_RD0554_01_s_2014_16					
Action/Comments						
Pipe						
Inspector Comments: Unauthorized pipe repair done without CVFPB permit. No new photo taken during fall 2014.

Waterside view of the unauthorized pipe repair, new pump shown in picture. Photo taken 06-05-2014.
